Technical Service Bulletin

Bulletin: TSB-12-1

Subject: Peerless® PureFire® PF-210 & PF-399 Flue Sensor Grommet

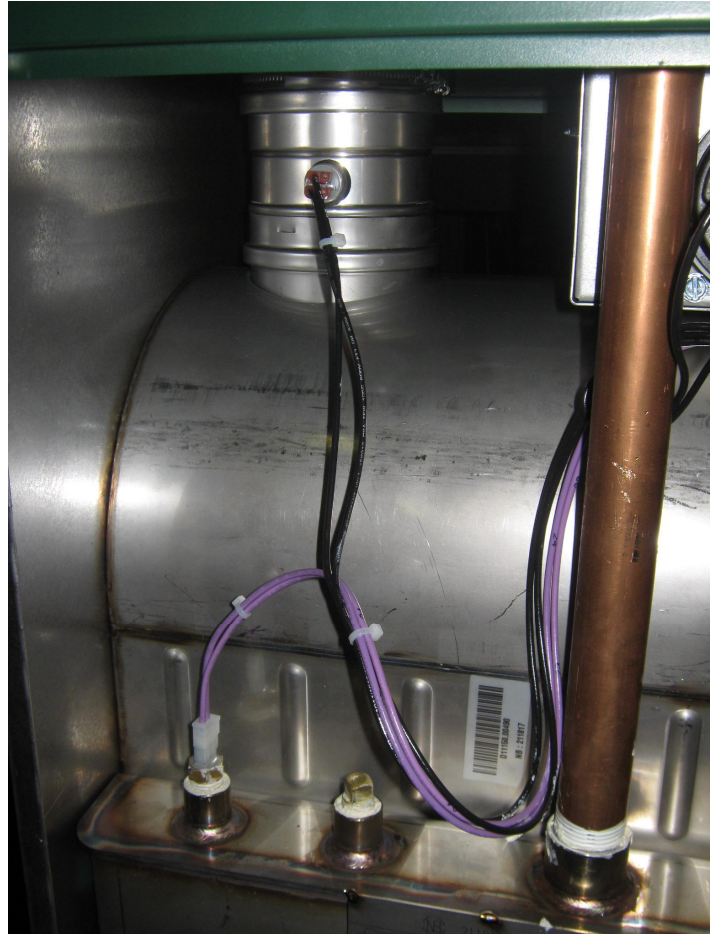
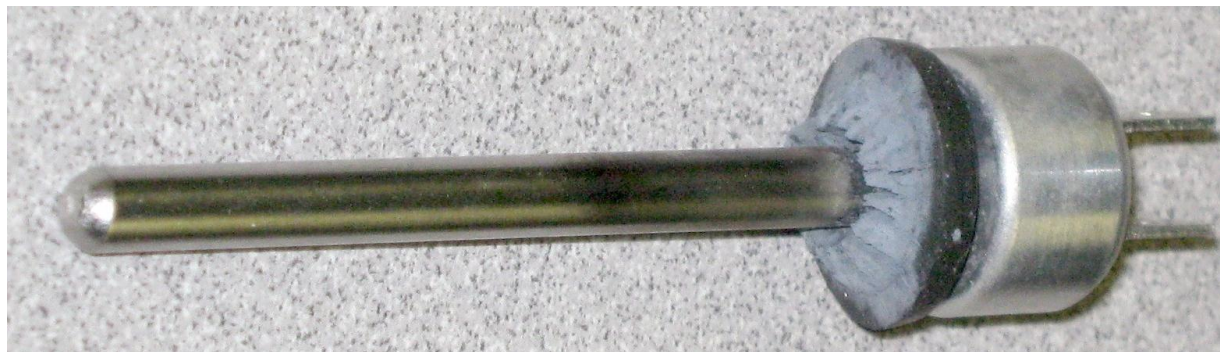
Issue: In certain circumstances, PB Heat, LLC has found deterioration of the grommet which holds the flue temperature sensor into the exhaust outlet adapter of the heat exchanger.

This degradation can cause the flue sensor to be dislodged from the flue pipe and may allow flue products to recirculate through the swirl plate and combustion air fan in the boiler.

In addition, this condition can allow acidic condensate to drip onto internal components of the boiler. The most likely result of dripping condensate may be A33 Fan Speed Errors and eventual component failure of the combustion air blower.

Action: Grommets on boilers manufactured before should be checked to see if they have been updated. Routine inspection of PF-210 and PF-399 boilers should include inspection of the flue sensor grommet.

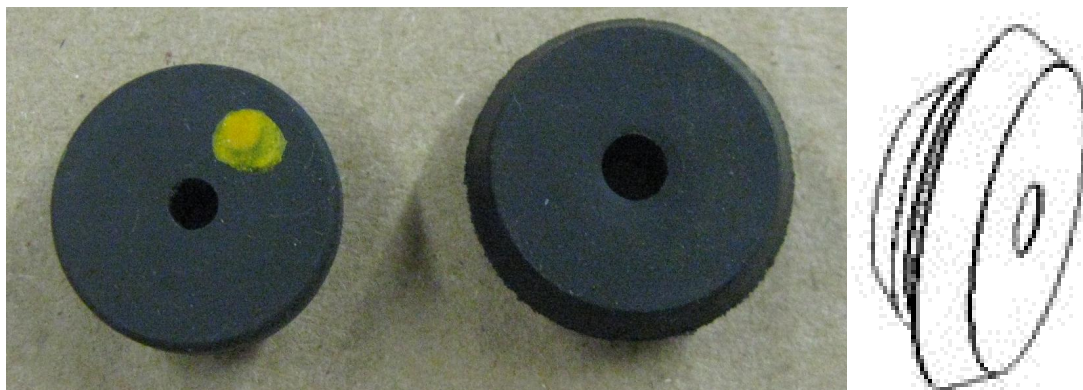
The new grommets will either have a yellow/green paint indicator or a tapered perimeter design as shown below.

Grommets found that do not have a paint mark or tapered head should be replaced with new grommets whether or not they show signs of deterioration.
